Contract #: 04-0120F4Cty: SF/ALA Rte: 80 PM: 13.2/13.9File #: 99.28**WELDING INSPECTION REPORT****Resident Engineer:** Casey, William**Address:** 333 Burma Road**City:** Oakland, CA 94607**Report No:** WIR-029971**Date Inspected:** 28-Aug-2013**Project Name:** SAS Superstructure**OSM Arrival Time:** 600**Prime Contractor:** American Bridge/Fluor Enterprises, a JV**OSM Departure Time:** 1530**Contractor:** Steward Machine Co.**Location:** Birmingham AL**CWI Name:** Fred Hudson**CWI Present:** Yes No**Inspected CWI report:** Yes No N/A**Rod Oven in Use:** Yes No N/A**Electrode to specification:** Yes No N/A**Weld Procedures Followed:** Yes No N/A**Qualified Welders:** Yes No N/A**Verified Joint Fit-up:** Yes No N/A**Approved Drawings:** Yes No N/A**Approved WPS:** Yes No N/A**Delayed / Cancelled:** Yes No N/A**Bridge No:** 34-0006**Component:** E2 Shear Key Anchorages**Summary of Items Observed:**

WELDING INSPECTION REPORT

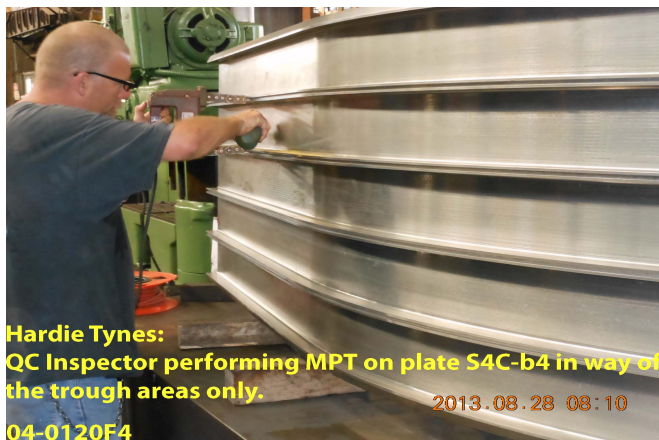
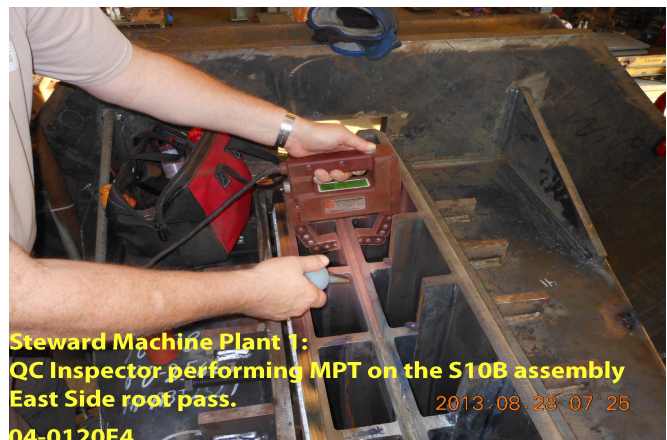
Assembly S10B (Root Pass, East Side) at Steward Plant 1:

- Visual Testing (VT) & Magnetic Particle Testing (MPT) Accept. (See TL-6028 for detailed information.)
